Amtec Welding Products

Case Study #1 - Rail Road Track Repair

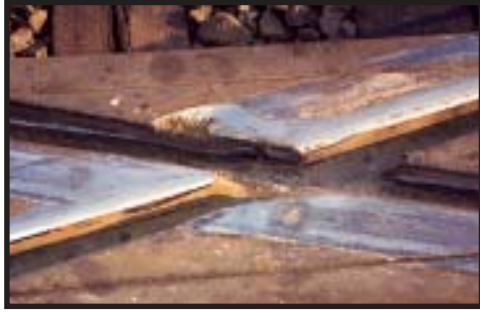
#1. A manganese crossover on a railroad that has fatigued under wear and tear, and has actually broken away from the main heavy section.

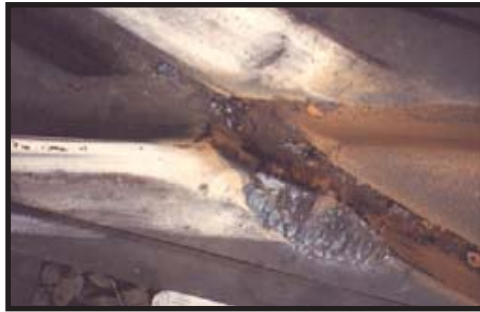
#2. Amtec #8 Airless Gouging Rod is used to remove the unwanted, damaged manganese steel, prior to grinding and re-welding.

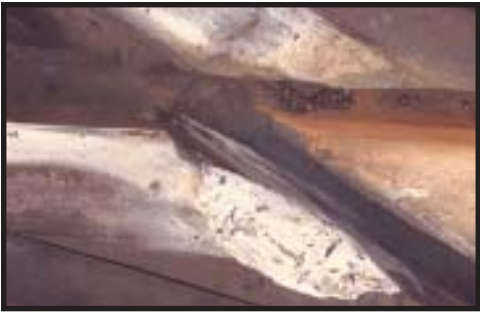
#3. The ground area after the damaged manganese piece has been removed by gouging.

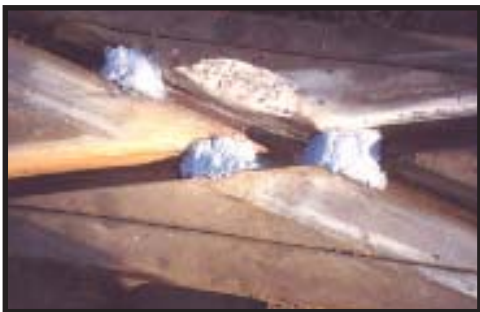
#4. Using Amtec Protecta as a dam to hold water in the welding area to keep the manganese steel crossover from overheating during the welding process.

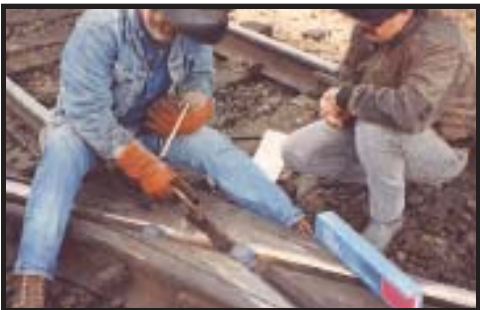
#5. Cleaning the slag away as the welder prepares to build up the manganese crossover.

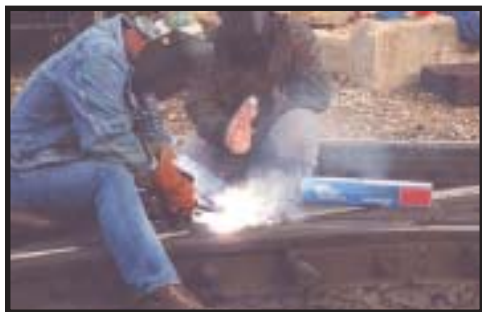
#6. Building up the railroad crossover using Amtec 207CNMG Electrode.

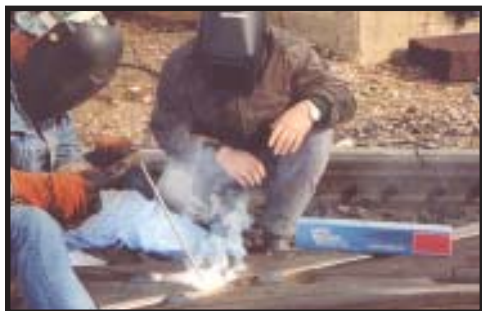
7. Amtec Protecta keeps the water in place to keep the manganese cool as the welding is done using Amtec 207 CNMG.

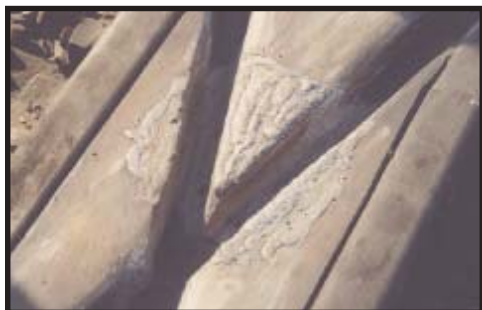
#8. The crossover has been welded successfully, and is ready for grinding and finishing.

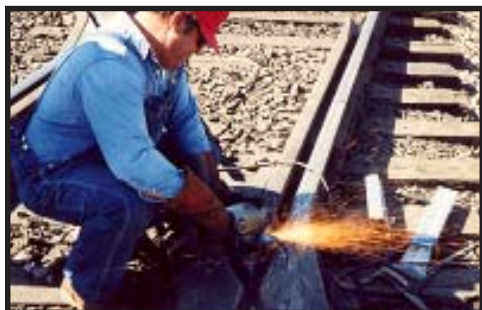
#9. The welded area is ground finished to shape and size.

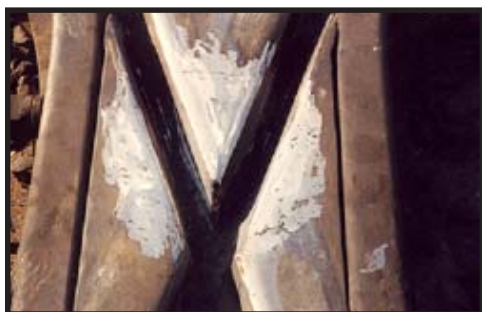
#10. The crossover is completely finished and ready for railroad traffic again. The job took less than 2 hours of actual welding time, which included the grinding and preparation.
